Detecting and Geolocating the Source of GPS Interference

Repeating antenna causing issues for Telco

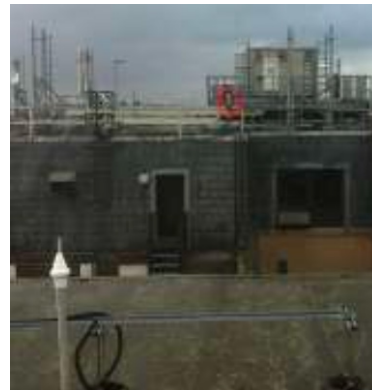
Repeating antenna is circled in red with GPS antenna in foreground

Chronos re-visited the site with handheld GPS interference detectors, CTL3500 and CTL3520, to determine the source of interference. Within a few minutes the source was discovered and located using the CTL3520 handheld with GPS direction finding capability. Once the offending antenna was detached, all the affected GPS systems reported stronger signals and began to lock.
