# Detecting and Geolocating the Source of GPS Interference

## Repeating antenna causing issues for Telco

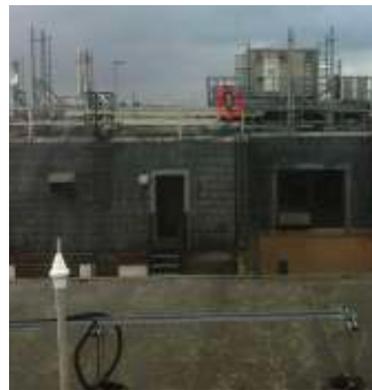
Repeating antenna is circled in red with GPS antenna in foreground

Chronos re-visited the site with handheld GPS interference detectors, CTL3500 and CTL3520, to determine the source of interference. Within a few minutes the source was discovered and located using the CTL3520 handheld with GPS direction finding capability. Once the offending antenna was detached, all the affected GPS systems reported stronger signals and began to lock.
