# Major Telecom Operator's Timing Disrupted

## GPS Jammer Employed to Defeat a Fleet Tracking System Disrupts Telco's Timing

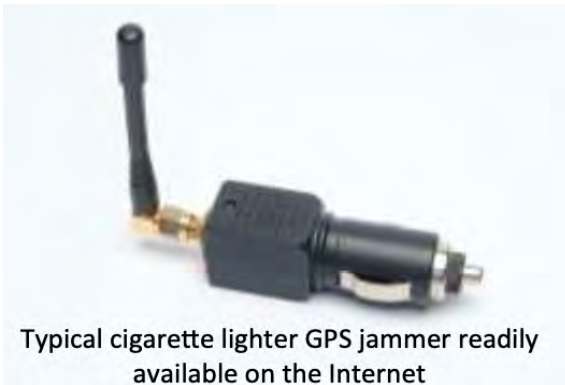
Typical cigarette lighter GPS jammer readily available on the Internet

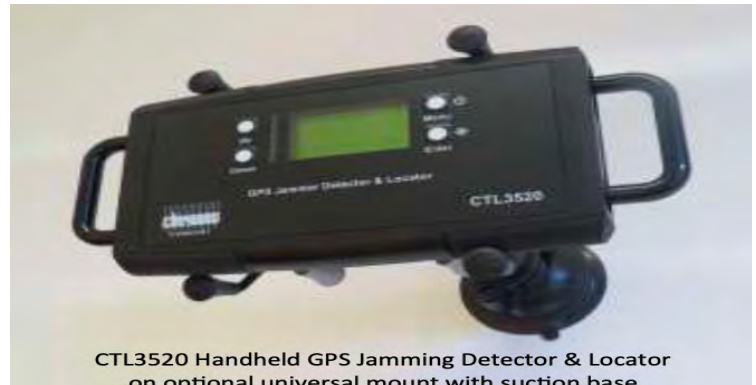
CTL3520 Handheld GPS Jamming Detector & Locator on optional universal mount with suction base

The sporadic nature of the events meant that a little luck would be needed for the engineer to be onsite at the time of an event. However, on the second and third site visits, the engineer was able to capture two jamming events in action. The CTL3510 was initially used to detect the presence of an interfering signal, the results of which were later downloaded and matched to the outage times seen by the SSU. The CTL3520 was then used to locate the source of the interference.

Using the CTL3520, the engineer was able to locate jamming signals coming from two vehicles both parked in the grounds of the plant equipment company.

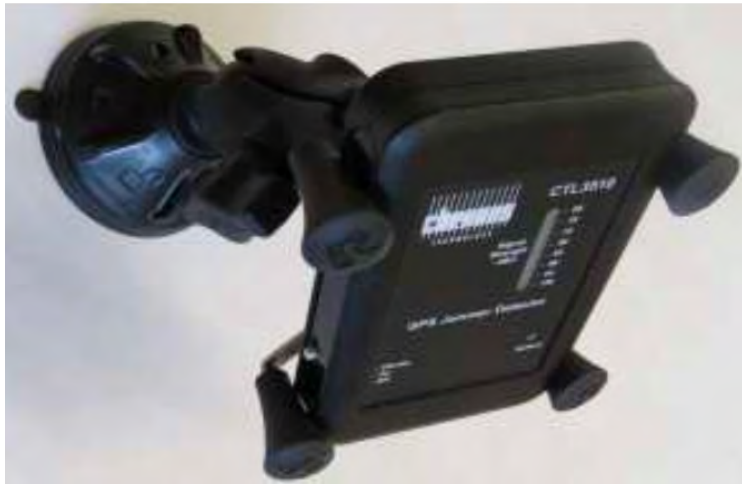
CTL3510 on optional universal mount with suction base
