# Major Telecom Operator's Timing Disrupted

## GPS Jammer Employed to Defeat a Fleet Tracking System Disrupts Telco's Timing

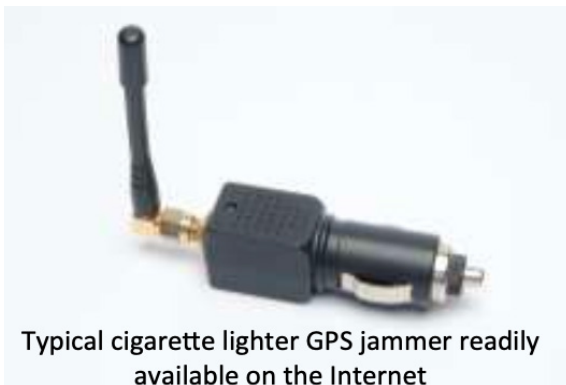
Typical cigarette lighter GPS jammer readily available on the Internet

After explaining the situation to the plant equipment company's fleet manager, and demonstrating the CTL3510 and CTL3520, the fleet manager was able to recover two jamming devices from company vehicles. It was suspected that up to three more jammers may also have been in use by other drivers based on the results from the tracking system.

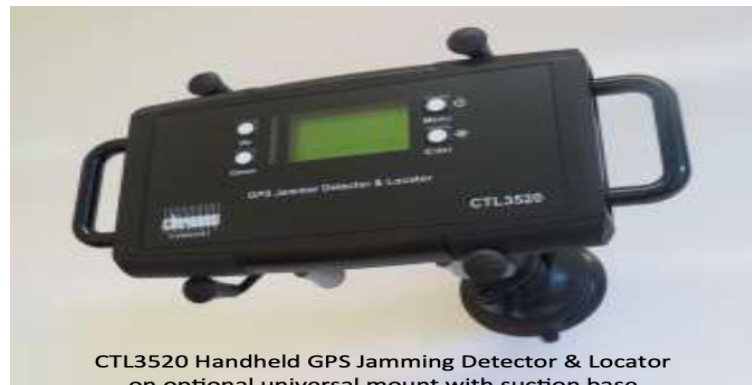
CTL3520 Handheld GPS Jamming Detector & Locator on optional universal mount with suction base

Using the CTL3520, the engineer was able to locate jamming signals coming from two vehicles both parked in the grounds of the plant equipment company.

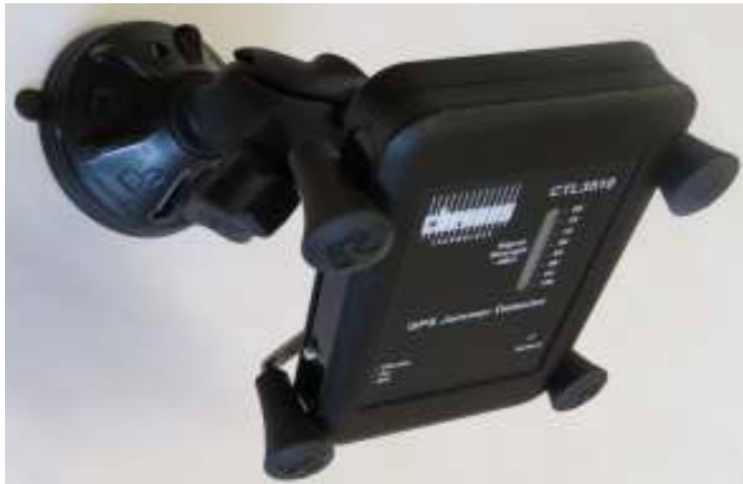
CTL3510 on optional universal mount with suction base

The sporadic nature of the events meant that a little luck would be needed for the engineer to be onsite at the time of an event. However, on the second and third site visits, the engineer was able to capture two jamming events in action. The CTL3510 was initially used to detect the presence of an interfering signal, the results of which were later downloaded and matched to the outage times seen by the SSU. The CTL3520 was then used to locate the source of the interference.
