Major Telecom Operator's Timing Disrupted

GPS Jammer Employed to Defeat a Fleet Tracking System Disrupts Telco's Timing

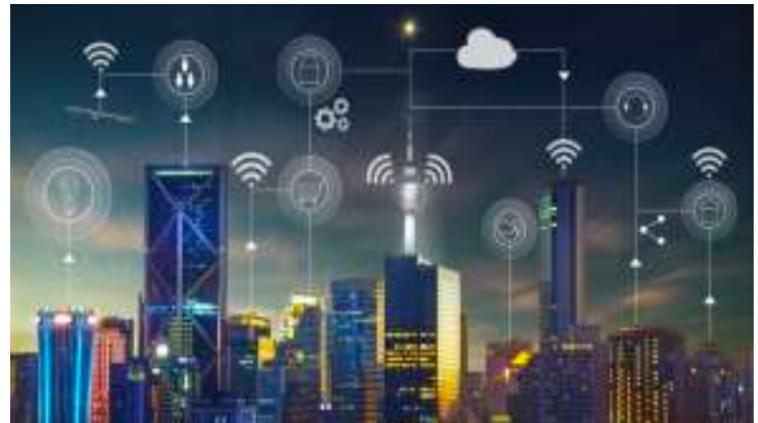
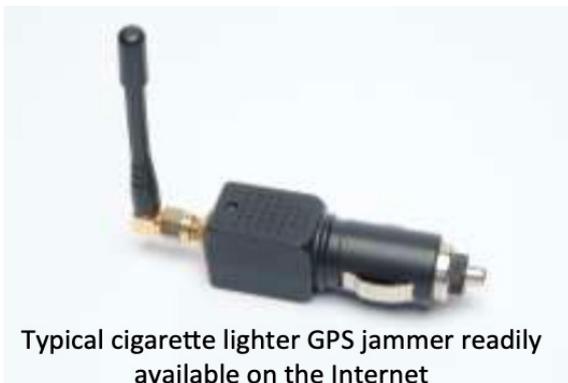
Typical cigarette lighter GPS jammer readily available on the Internet

After explaining the situation to the plant equipment company's fleet manager, and demonstrating the CTL3510 and CTL3520, the fleet manager was able to recover two jamming devices from company vehicles. It was suspected that up to three more jammers may also have been in use by other drivers based on the results from the tracking system.

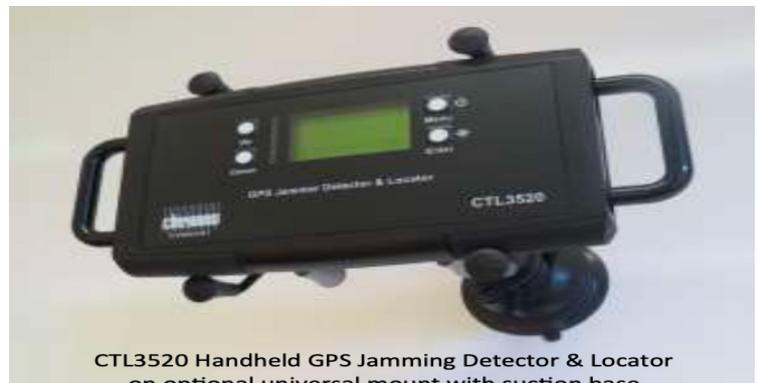
CTL3520 Handheld GPS Jamming Detector & Locator on optional universal mount with suction base

The sporadic nature of the events meant that a little luck would be needed for the engineer to be onsite at the time of an event. However, on the second and third site visits, the engineer was able to capture two jamming events in action. The CTL3510 was initially used to detect the presence of an interfering signal, the results of which were later downloaded and matched to the outage times seen by the SSU. The CTL3520 was then used to locate the source of the interference.

Using the CTL3520, the engineer was able to locate jamming signals coming from two vehicles both parked in the grounds of the plant equipment company.

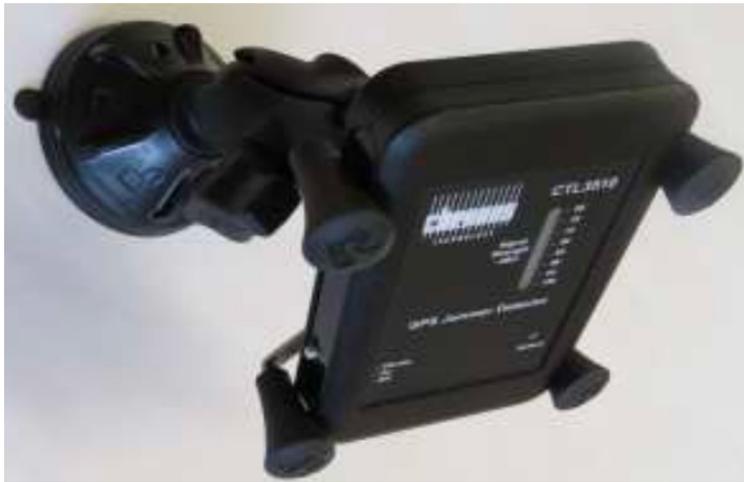
CTL3510 on optional universal mount with suction base
